Dynamic Tests Of Short Sections Of Corrugated Metal Beam
Guardrail Series XIII

October 1968

State of California
Department of Public Works
Division of Highways
Materials and Research Department

October 1968
Interim Report
M & R No. 636392-4
D-4-37

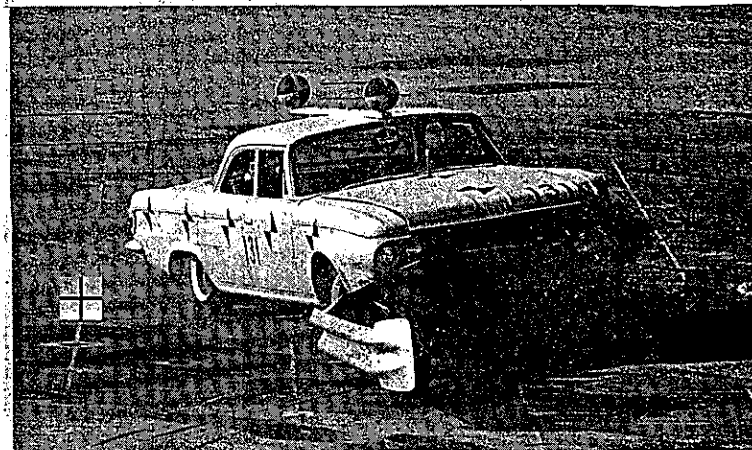
Figure 2

The test vehicle in Test 131 impacted the barrier near the center post at 63 mph/25 deg. The beam pocketed almost immediately upon impact (Figure 2), was pulled free of all but one of the posts, and was dragged, intact, by the vehicle as it penetrated through the installation with only a 3-deg change in direction, Plate A (Appendix).

The tendency of this short barrier to deflect laterally as a unit indicated that the combined resistance of the beam-to-post connections is less than the strength of the beam and was not sufficiently rigid to contain the impacting vehicle. The bolt-washer modification appeared to add sufficient bearing area at the face of the beam to resist bolt pull through. This was evident in that only one bolt pull through failure was observed, while the other six bolts pulled free at the posts and remained attached to the beam. This would indicate that the increased area provided by the washers help in transmitting impact tensile beam loads.

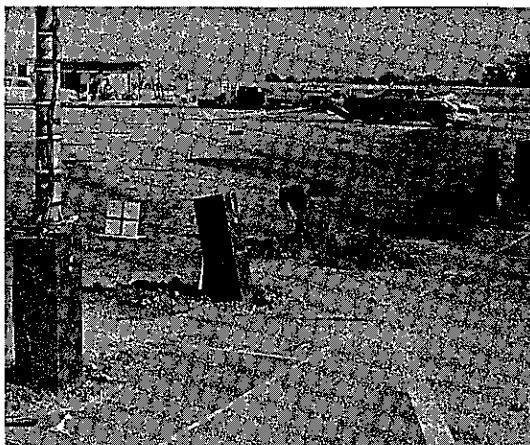
Figure 3

All beam sections, posts, and block-out blocks were damaged (Figure 3). The vehicle sustained major front end damage and was considered a total loss (Figure 4).

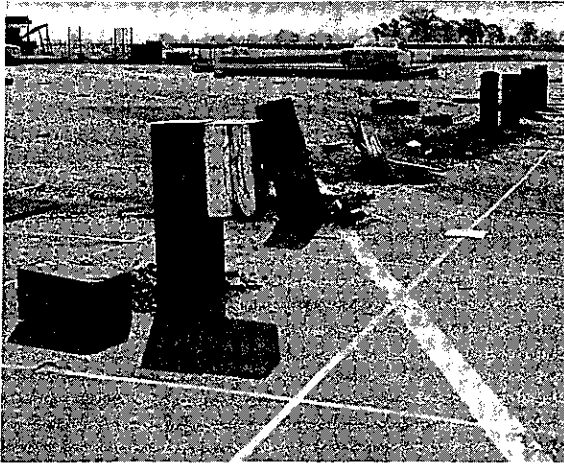
Figure 6

Although the over-all results of this test would probably not have been significantly different had round cut or rectangular plate washers been used under all bolt heads, it is notable that six out of the seven bolts without washers pulled through the metal beam. The transfer of the high axial load to the posts prior to the "pull through" failures was evident in that ten of the eleven posts were split.

All beam sections, posts, and block-out blocks were damaged (Figure 6).

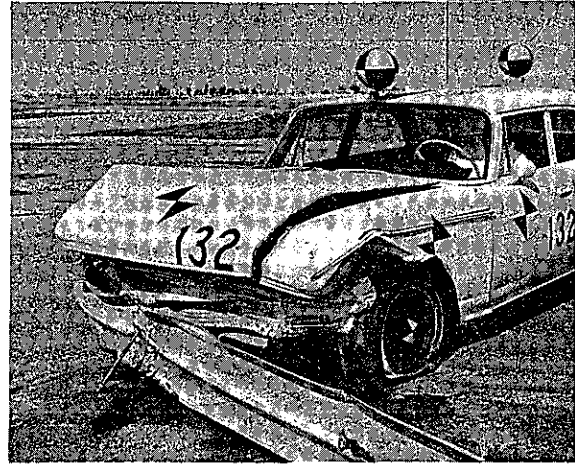
Figure 7

The vehicle sustained major front end damage and was considered a total loss (Figure 7).

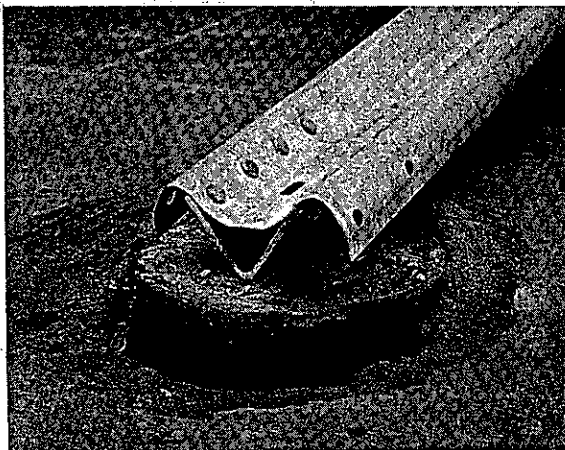
Figure 9

All beam sections were damaged as were two block-out blocks and one post. There were no bolt pull through failures. A 1/3-in. wide crack was opened in the downstream concrete footing which was displaced approximately 1/2 in. toward impact. The upstream concrete footing was displaced 2 1/2 in. toward impact (Figure 9) indicating the high tensile force transmitted by the guardrail beam.

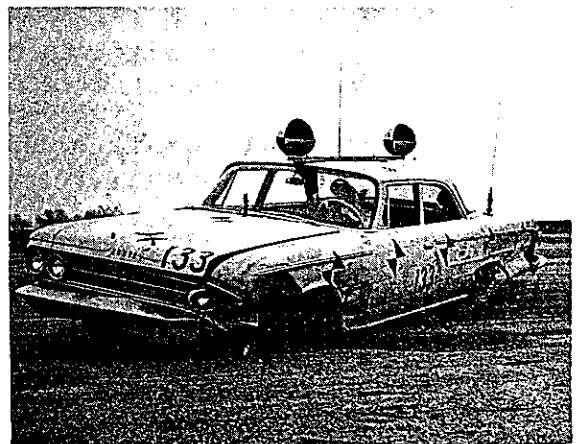
Figure 10

The vehicle sustained moderate damage as shown in Figure 10.

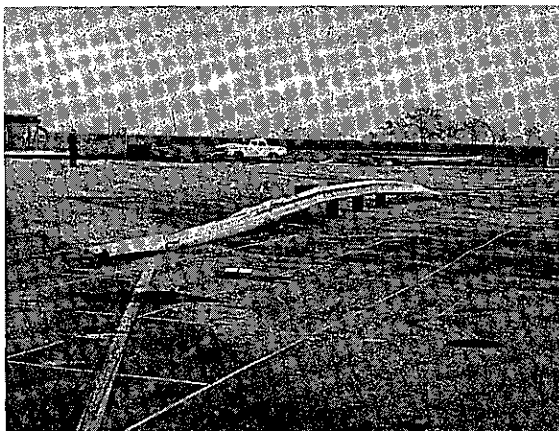
Figure 11

The test vehicle in Test 134 impacted the barrier at the planned point of impact at 63 mph/24 deg. The beam at this point was too low to effectively resist the vertical downward force of the impacting left front wheel which deflected the beam down, permitting the vehicle to ride up and over the beam. This imparted a counter-clockwise rolling moment to the vehicle which completely overturned as it vaulted the barrier coming to rest 180 ft beyond impact in a regained upright position, Plate D (Appendix).

The end section of beam was destroyed and one post and block-out block shattered (Figure 11). The vehicle sustained major front, side, and top damage, and was considered a total loss (Figure 12).

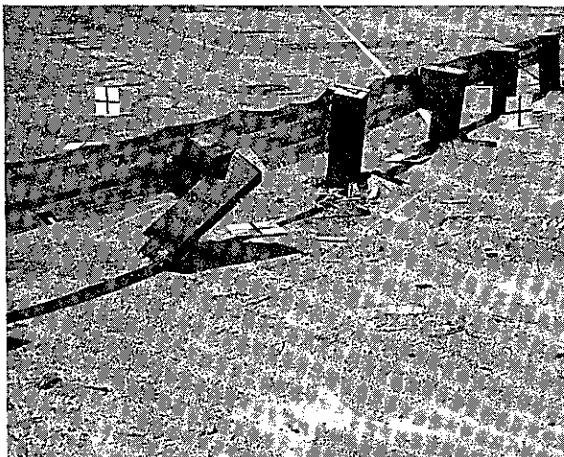
Figure 16

All beam sections were damaged. There were no bolt pull through failures although two block-out blocks crushed and one post was broken (Figure 16). The vehicle sustained moderate front end damage (Figure 17).

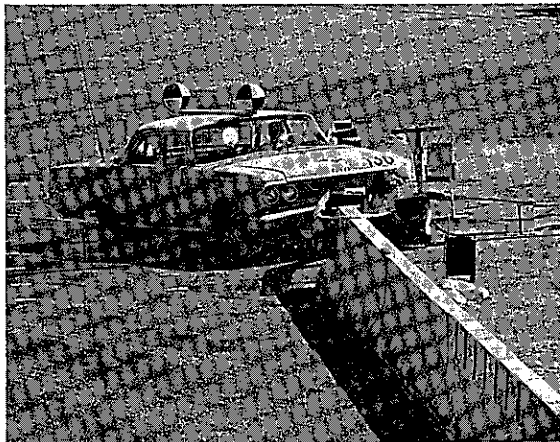
Figure 21

The test vehicle in Test 136 impacted the barrier 18-ft upstream of the simulated bridge end post at 60 mph/33 deg. pocketing the beam severely (Figure 21).

Analysis of the data film indicates that even if the concrete end post had not failed, beam deflection and pocketing were already occurring to such an extent that the vehicle would not have been redirected sufficiently to avoid an end-on collision into the concrete bridge end post.

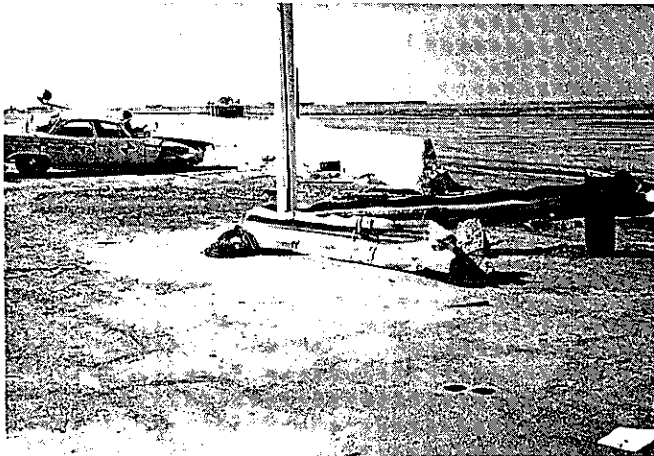
Figure 22

As the vehicle was being redirected (approximately 12 deg) the concrete end post failed through the connecting holes, allowing the guardrail beam to pull free, thus permitting the vehicle to penetrate the barrier. As the vehicle progressed through impact, the right front wheel struck the end of the concrete end post throwing the vehicle into a violent counter clockwise roll-over. The vehicle came to rest 45 ft beyond impact in a regained upright position (Figure 22), Plate F (Appendix).

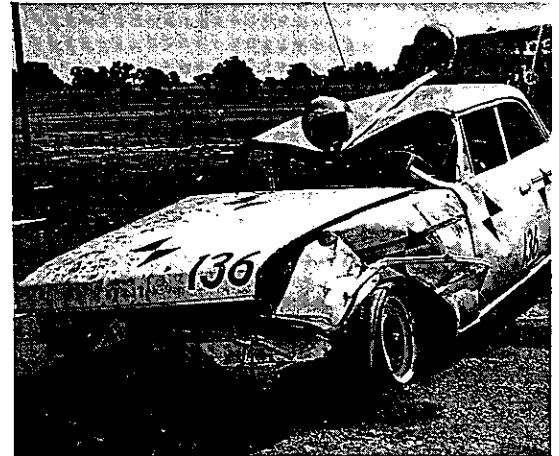
Figure 23

Two sections of beam were damaged. Although barrier damage was considered severe with three timber posts broken off and four block-out blocks shattered, there were no bolt pull through failures. The vehicle sustained major front, side, and top damage and was considered a total loss (Figure 23).

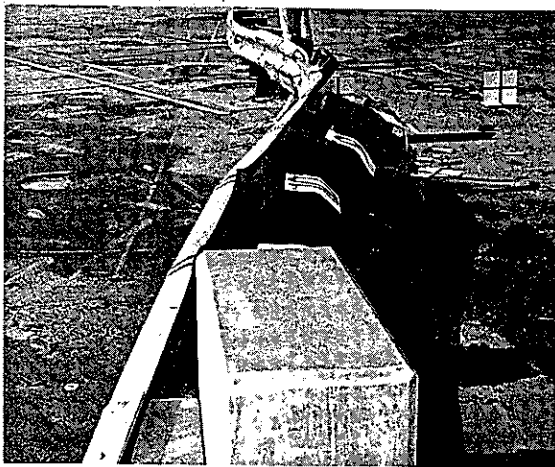
Figure 26

Three sections of beam were damaged, two timber posts broken off and two block-out blocks shattered. Again,

there were no bolt pull through failures. The guardrail beam sustained a permanent lateral deflection of 2.1 ft (Figure 26).

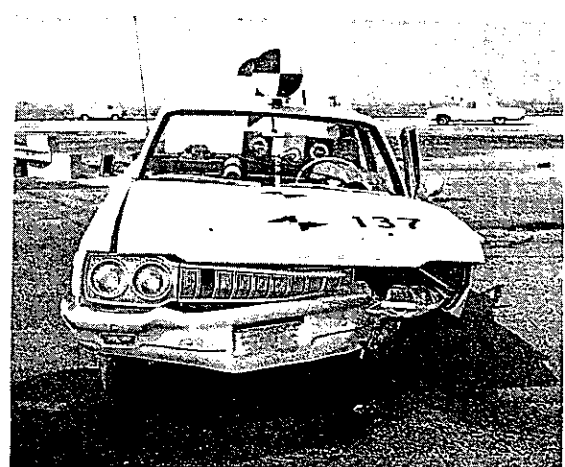
Figure 27

Even though vehicle dynamics in this high speed oblique angle collision were considered good through impact, the left front wheel was torn off the test vehicle which sustained major front end and undercarriage damage as shown in Figure 27.

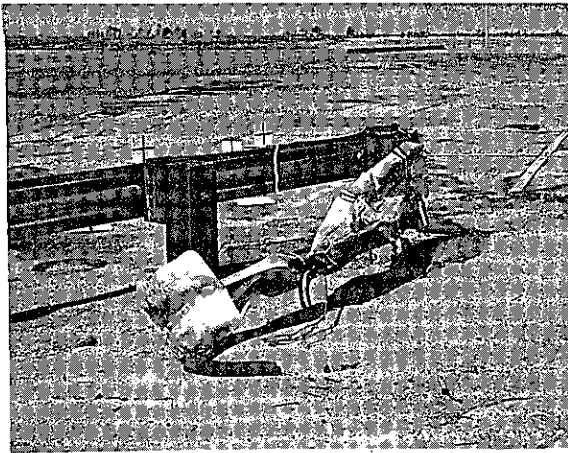
Figure 28

The first two posts were broken off at ground level and completely shattered. The end 12-ft of metal beam guardrail was twisted and doubled back around post 3 which was

deflected laterally 0.7 ft. The remainder of the barrier was intact with no significant movement or damage (Figure 28). There were no bolt through failures. This again illustrates the effectiveness of the plate washers, which have subsequently been adopted as a California standard for use on guardrailing.

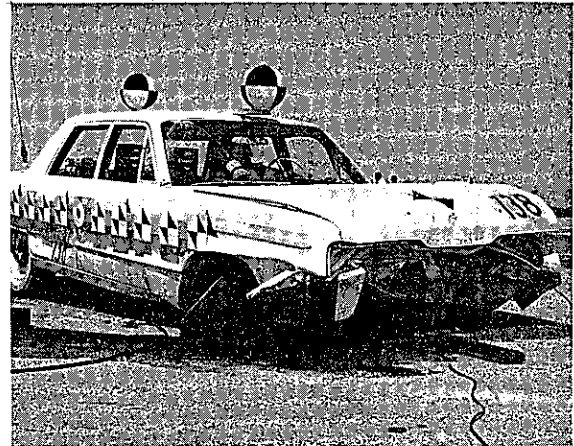
Figure 29

The vehicle sustained major front end damage with both front wheels smashed back under the engine compartment and was considered a total loss (Figure 29).
